Failure Analysis of Three Si_3N_4 Balls

1 December 2001

M. J. O'BRIEN
Space Materials Laboratory
Laboratory Operations

6. AUTHOR(S) M. J. O'Brien and N. Presser				5d. PROJECT NUMBER	
				5e. TASK NUMBER	
				5f. WORK UNIT NUMBER	
7. PERFORMING ORGANIZATION NAME(S) AND ADDRESS(ES) The Aerospace Corporation Laboratory Operations El Segundo, CA 90245-4691				8. PERFORMING ORGANIZATION REPORT NUMBER TR-2001(8565)-1

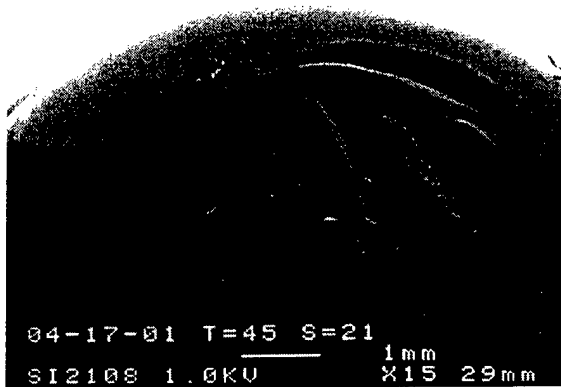
Fig 1

Figure 1 is a low-magnification view of the entire spall from a perspective perpendicular to the spall. The circular Wallner lines seem to radiate on the left and right from an initiation site labeled "A," with the concave sides of the Wallner lines pointing back towards this initiation site. The site labeled "A" is a broad, flat "plateau."

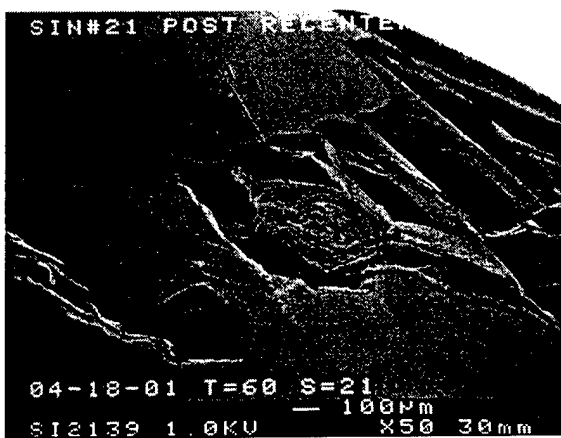
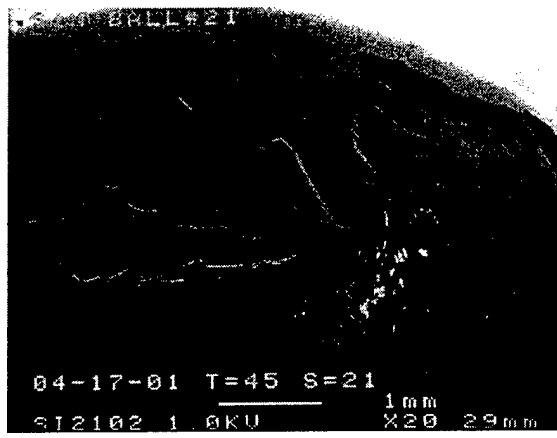
Fig 2

Figure 2 is another low-magnification view centered on site "A" showing the neighboring Wallner lines more distinctly. Figure 3 is a slightly higher magnification view at 50x centered to the right-hand side of the site "A" and Figure 4 is a companion view at 20x centered to the left-hand side of the site "A." Figures 3 and 4 are taken at oblique angles to highlight the concave Wallner lines, which again point back towards the site "A," which is therefore identified as the initiation site.

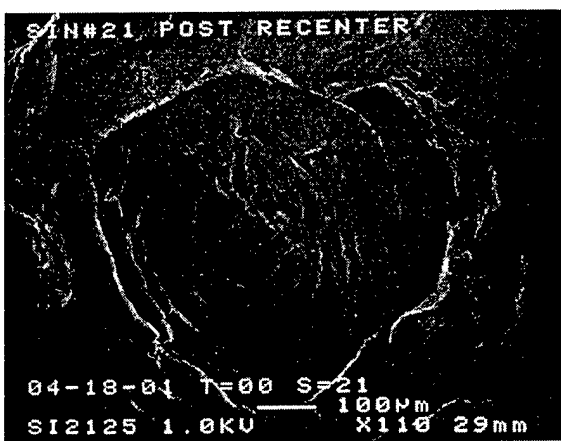
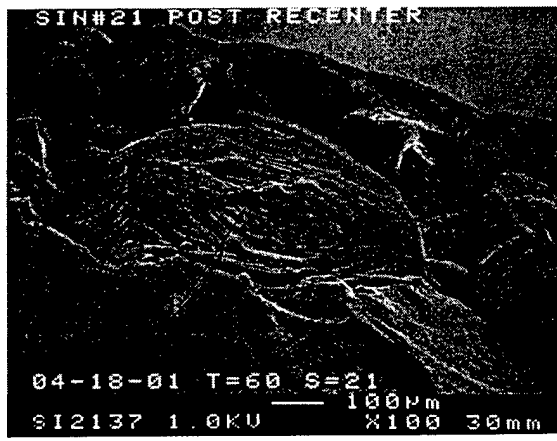
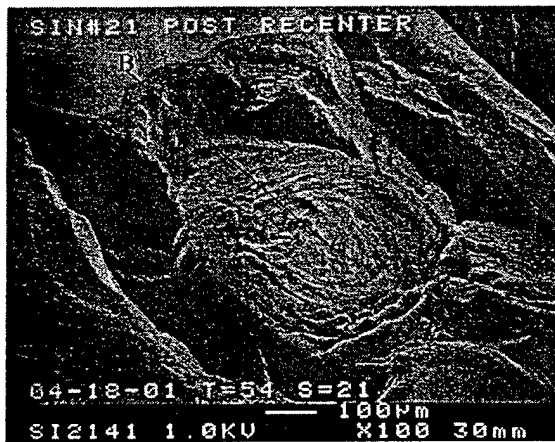
Fig 5

Figures 5, 6, and 7 are a series (at magnifications of 110x, 100x, and 100x) centered on the site "A." Figure 5 is from an orthogonal perspective, and Figures 6 and 7 from oblique perspectives. The circular Wallner lines seen in site "A" form a "bull's eye" pattern around a central point, labeled "B," which is within the region labeled "A" and approximately in its center. The pattern of Wallner lines implies that site "B" is the upstream location where failure initiated.

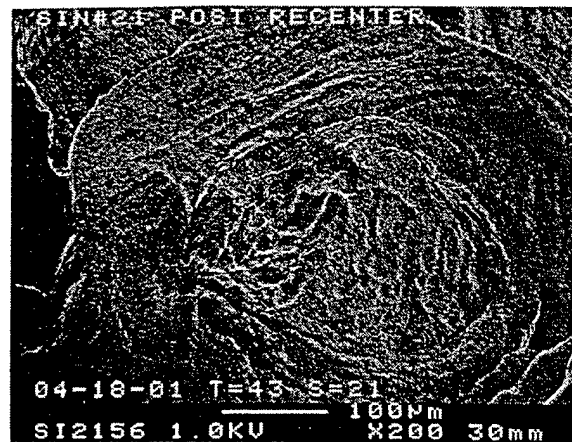
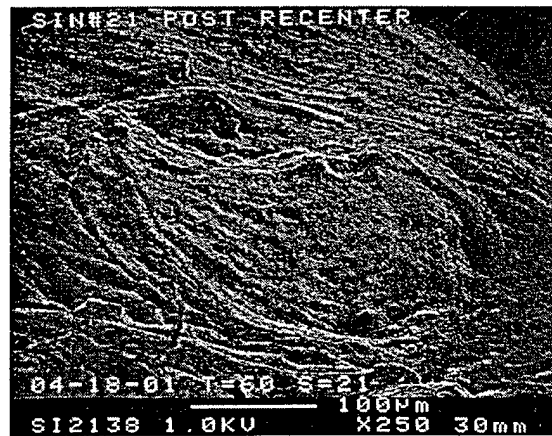
Fig 8

Figures 8 and 9 are views at 200x and 250x centered at site "B." Detailed inspection of site "B" at still higher magnifications did not seem to reveal a clear cause for the initiation of the fracture on site "B."

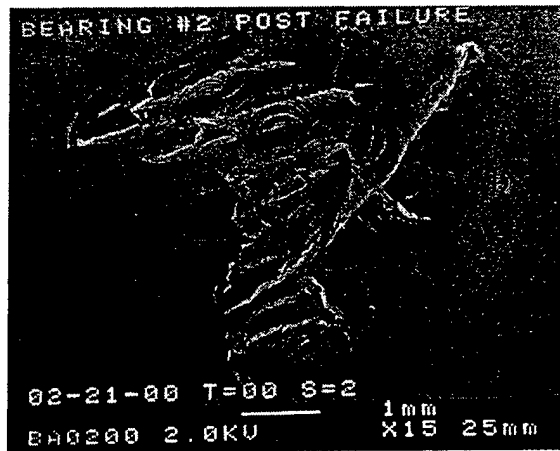
Fig 10.

Figure 10 is a low-magnification view of the entire spall from a perspective orthogonal to the spall. The circular Wallner lines are evident in the upper and middle parts of the spall, and the concave lines seem to radiate back to a point in the lower part of the spall. To orient the discussion of subsequent fractographs that show finer detail, four features are labeled in Figure 10. Feature "A" is a region of Wallner lines in the middle of the spall. Feature "B" is a region of Wallner lines in the lower part of the spall. Feature "C" is a void in a triangular pocket defined by the intersection of three cracks. The long diagonal line labeled "D" is a deep "trench-like" fracture that is not obvious from this perspective.

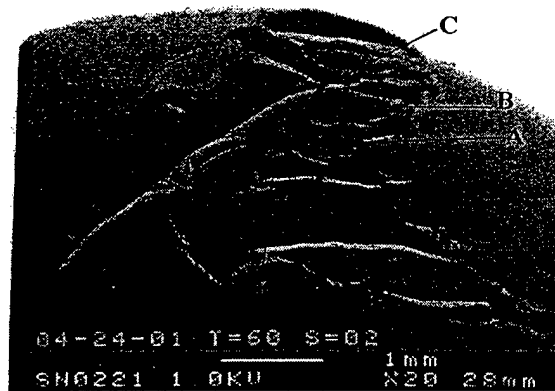
Fig 11

Figure 11 is a low-magnification oblique view showing better the Wallner lines in the upper region of the spall. Features "A" and "B," which are the regions of Wallner lines, are labeled and reinforce the observation that the upstream location of the fracture initiation is in the lower part of the spall with the middle and upper parts of the spall downstream from the initiation site. The location of the void

is labeled "C," although the triangular pocket is not obvious in this view. The long and deep fracture, labeled "D," is more obvious in this view. An interesting feature, labeled "E," is a patch of virgin surface that did not spall away.

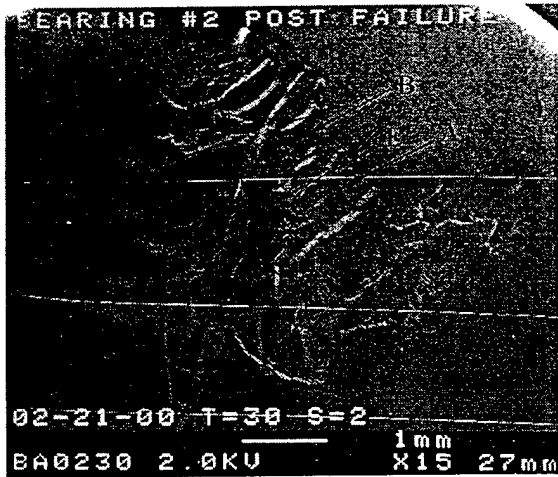
Fig 12

Figures 12, 13, and 14 are low-magnification views taken by successively rotating the line of sight. The concavity of the regions of Wallner lines, labeled "A" and "B," again reinforce that fracture initiation occurred in the lower part of the spall. The location of the void, labeled "C," is labeled in the lower part of the spall. The deep fracture, labeled "D," is seen to intersect the void. Actually, these three views cumulatively show that three separate fractures intersect at the void. To provide a landmark, the location of the unspalled virgin surface is labeled "E."

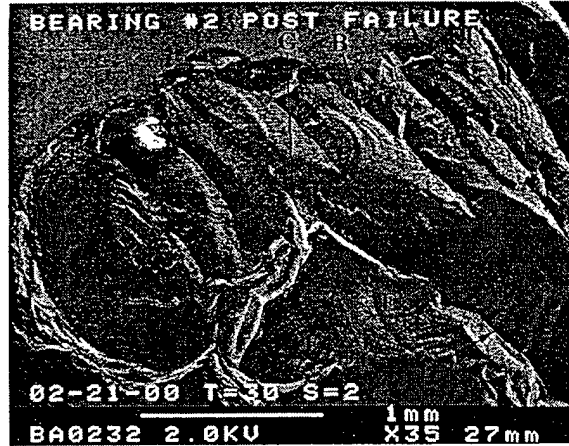
Fig 15

Figures 15 and 16 are orthogonal views of the lower part of the spall at higher magnifications. The Wallner lines, labeled "A" and "B," show that fracture initiated between region "B" and the lowermost part of the spall. That is, region "A" is downstream of region "B," which, in turn, is downstream of the site of fracture initiation. Void "C" is located in this area upstream of the region "B" and is considered a possible candidate responsible for initiation of the spall. The deep crack, "D," radiates from the void, as do two other cracks, labeled "F" and "G".

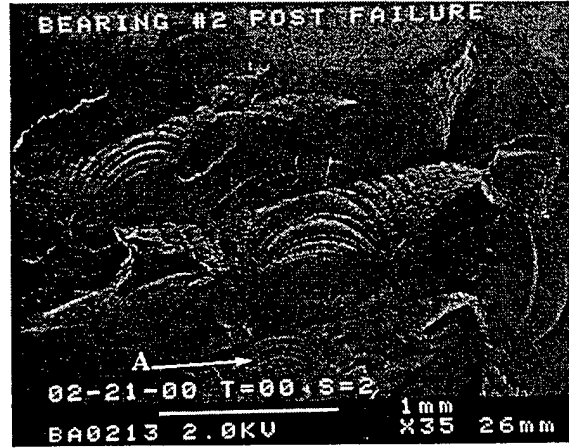
Fig 17

Figure 17 is an higher magnification orthogonal view of the middle and upper parts of the spall. The Wallner lines labeled "A" are visible, although the other region of Wallner lines, "B," is just beneath the lower edge of the frame and is not visible. Again, the concave sides of the Wallner lines point upstream to the site in the lower part of the spall where fracture initiated.

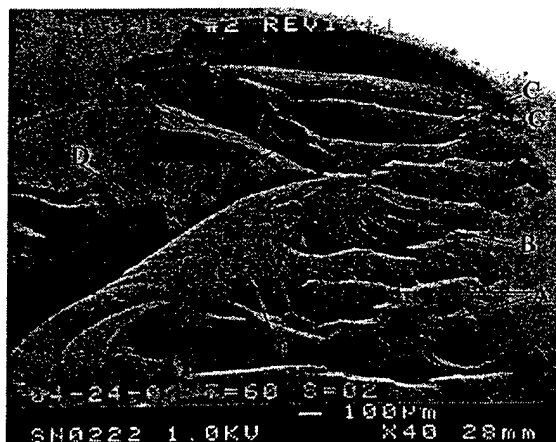
Fig 18

Figure 18 is an oblique view taken from a line of sight from the upper part of the spall. The Wallner lines, "A" and "B," are labeled. The void, "C," is not visible, but its location is labeled. The three cracks, "D", "F," and "G," are seen to be radiating from the location of the void. As a landmark, the unspalled spot of virgin surface is labeled "E".

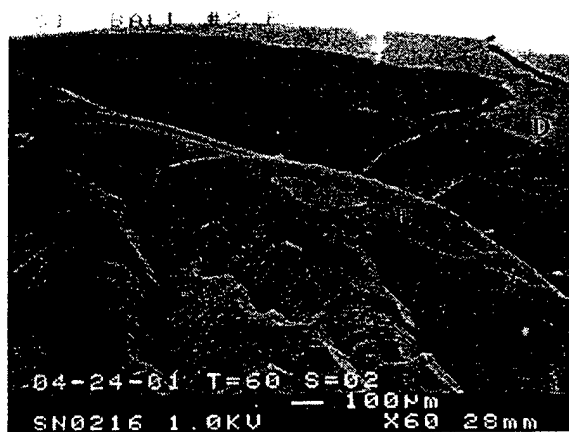
Fig 19

Figure 19 is an oblique view of the middle part of the spall whose line of sight is rotated from the line of sight used in Figure 18. The Wallner lines, "A" and "B," and the unspalled spot, "E," are labeled. The deep crack, "D," is seen running diagonally across the back of the fractograph.

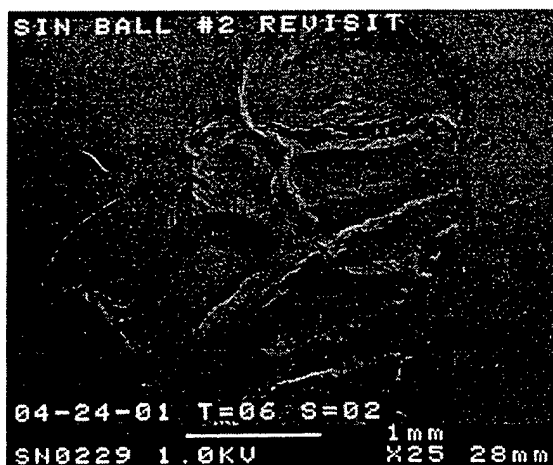
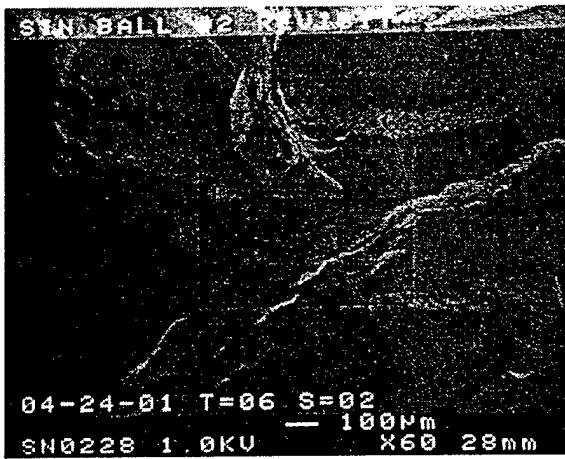
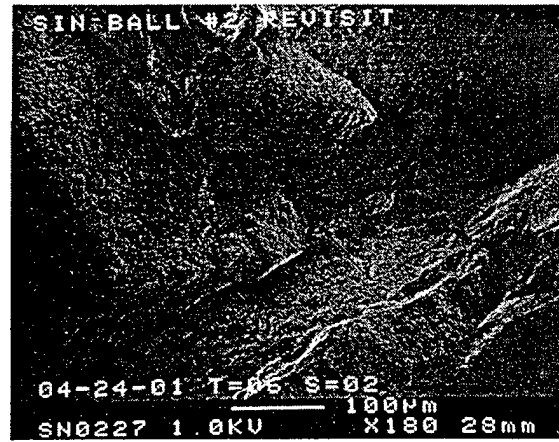
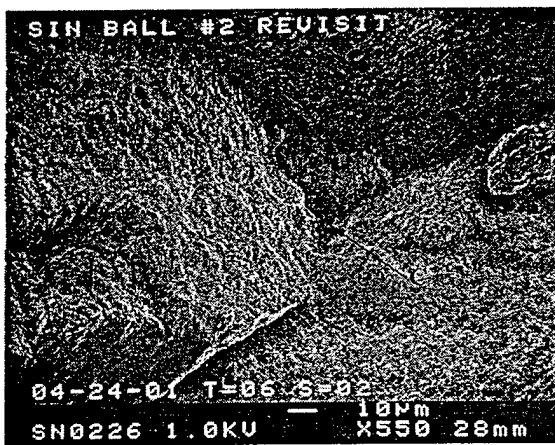
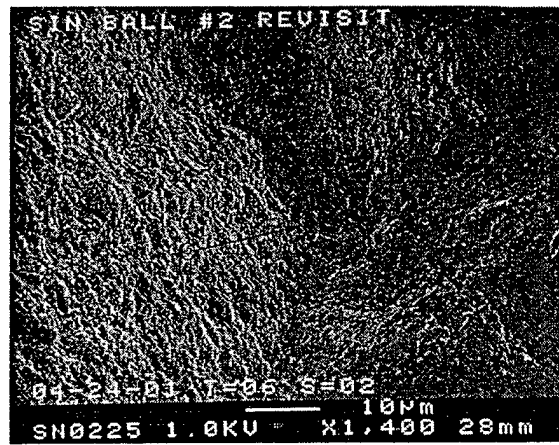
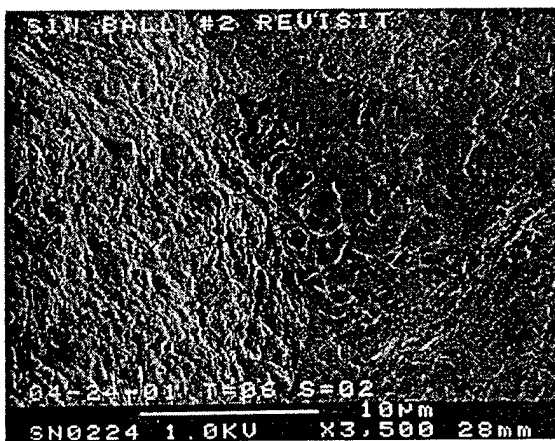
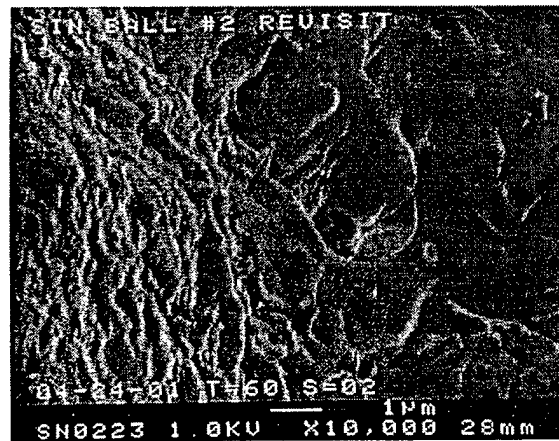
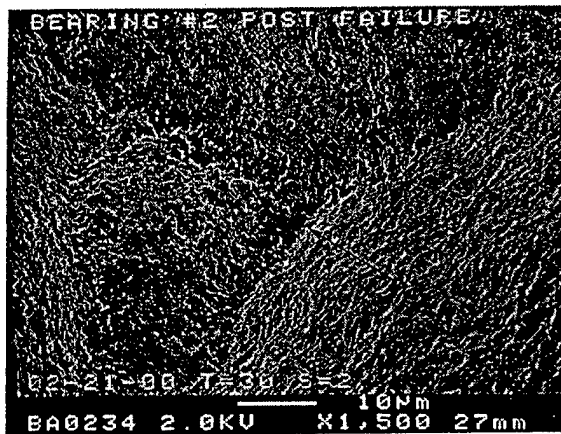
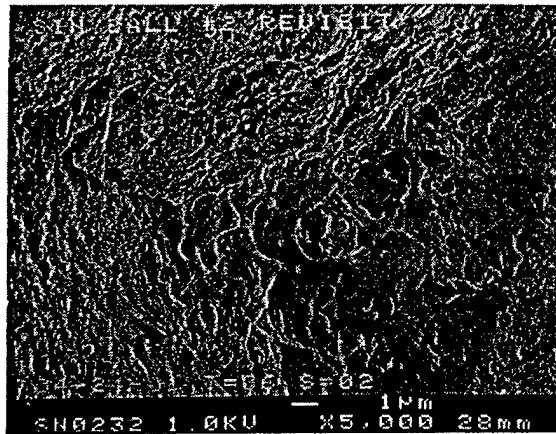
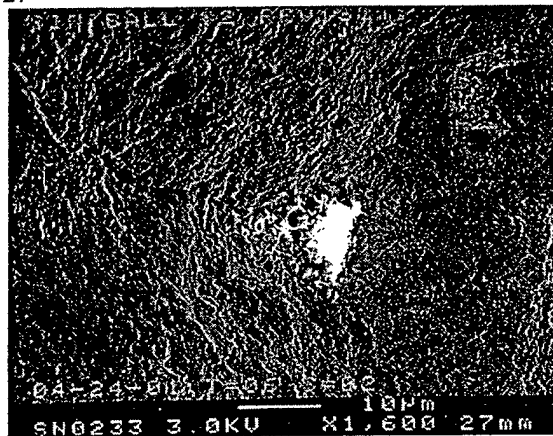
Figures 20, 21, 22, 23, 24, 25, and 26 are progressively higher magnification views (at 25x, 60x, 180x, 550x, 1400x, 3500x, and 10,000x, respectively) from an orthogonal perspective and centered on the void, "C," which is at the junction of the three cracks, "D," "F," and "G." Figure 27 is a view of the void at 1500x from a different perspective that "sights" down the bore of the void. Figure 28 is a view at an intermediate magnification of 5000x from still another perspective. Figure 29 is a micrograph at a slightly higher accelerating voltage, 3 kV, that shows that the region immediately around the void charges, although material further away does not.

The void, which is approximately 2 μm in diameter, sits in a triangular region whose appearance differs from the fracture surface around it, which is seen most clearly in Figures 25, 26, and 28. This change in appearance may imply that the triangular region is not the same chemistry as the material around it. For example, the region may be a pocket of segregated glassy material at the triple junction between adjacent grains of crystalline Si_3N_4 . The observation that the triangular region charges implies that the region has a higher electrical resistivity than the material around it. A higher electrical resistivity is consistent with a pocket of glassy material rich in the sintering aids used in this Si_3N_4 . The glassy sintering aids might be expected to be more insulative than the bulk Si_3N_4 ceramic.

Alternatively, the change in appearance might imply that the triangular region possessed a different history than the material around it during the fracture process. For example, if the void does happen to represent the initiation of the spall, then the region may be the site where a sub-critical pre-crack developed and slowly grew by fatigue over several million Hertzian loading cycles until it reached the critical size at which the rest of the spall fractured. During the course of the fatigue cycles, asperities may have been smoothed away as the opposing faces of the pre-crack opened and closed, giving the change in appearance compared to the larger fracture surface around it.

It is uncertain, however, whether the void represented the initiation site for the fracture, whether the void developed as damage late in the fracture, or whether the void was unrelated to the fracture. If the void was responsible for fracture initiation, it may be a small sintering pore where the ceramic did not fully densify.

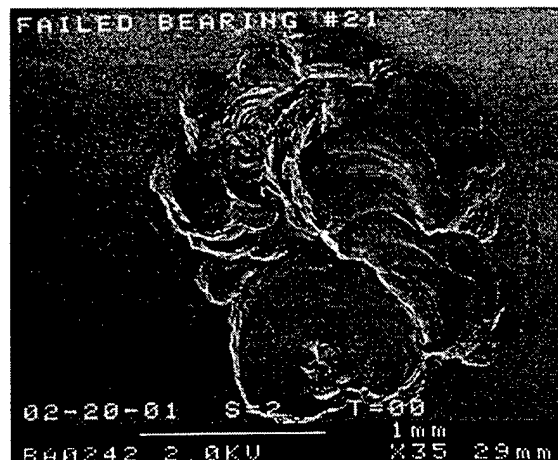
Fig 30

Figures 30, 31, and 32 are low-magnification views of the entire spall. The circular Wallner lines seem to radiate from a failure that originated in a broad, flat "plateau." The Wallner lines radiate down several "stepped" regions, with the concave sides of the Wallner lines pointing back towards the plateau from which the failure seems to have initiated. The concavity reinforces the notion that the plateau is "upstream" in the fracture, and the several stepped regions are "downstream." The feature "C" is labeled in Figure 32 but explained later in this discussion.

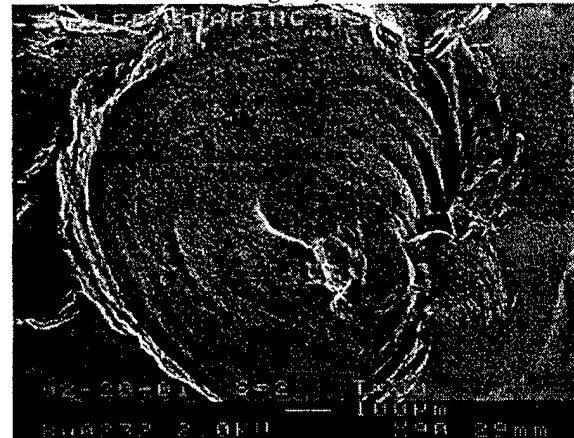
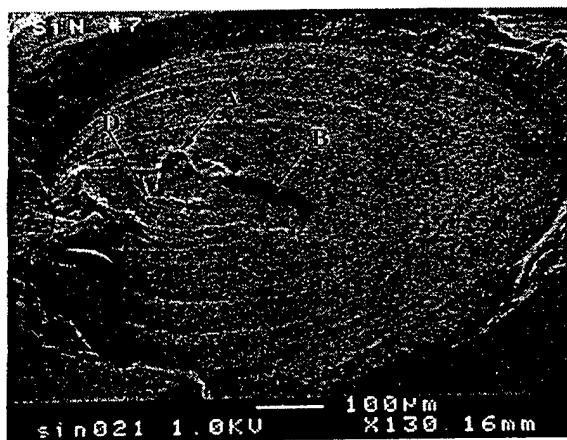
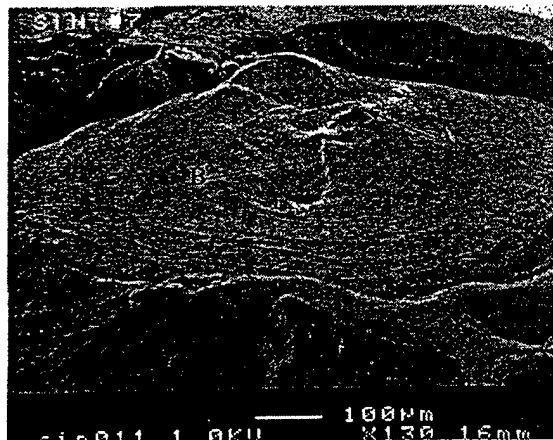
Fig 33

Figures 33, 34, and 35 are higher magnification views of the plateau from which fracture is believed to have initiated. The Wallner lines form a "bull's eye" pattern around a central point. The "thumb-

shaped" feature labeled "A" is a landmark used to orient subsequent discussion. Running off from point "A" is a crack-like feature labeled "B," which charges slightly in Figure 33. Another landmark is labeled "D."

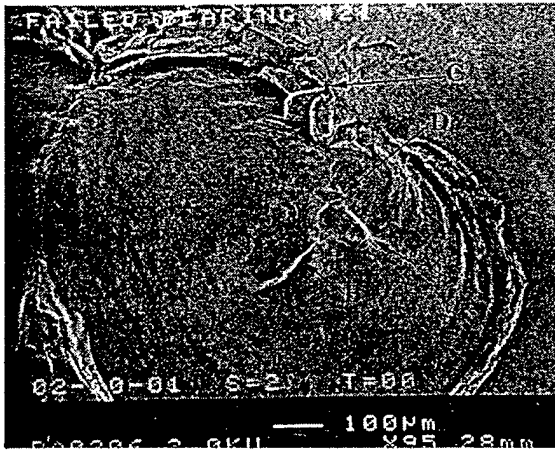
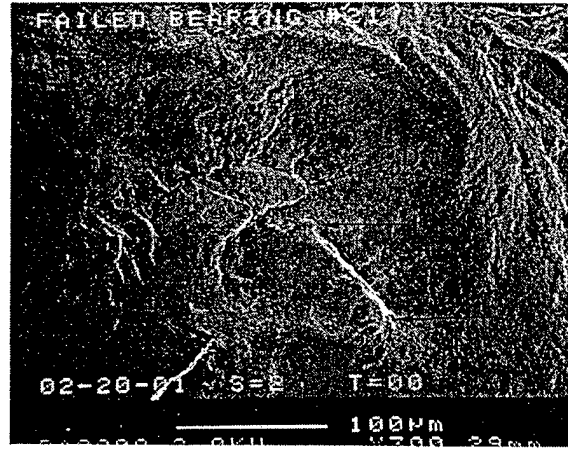
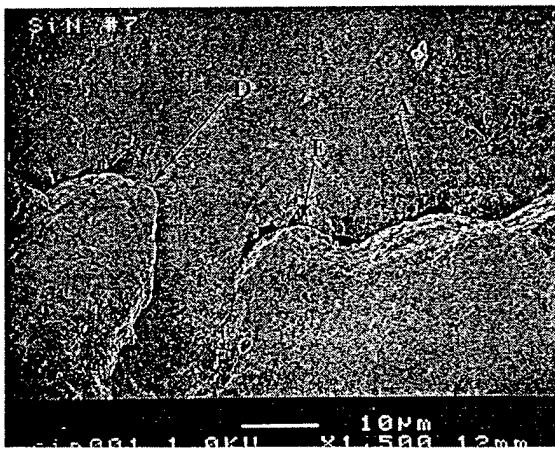
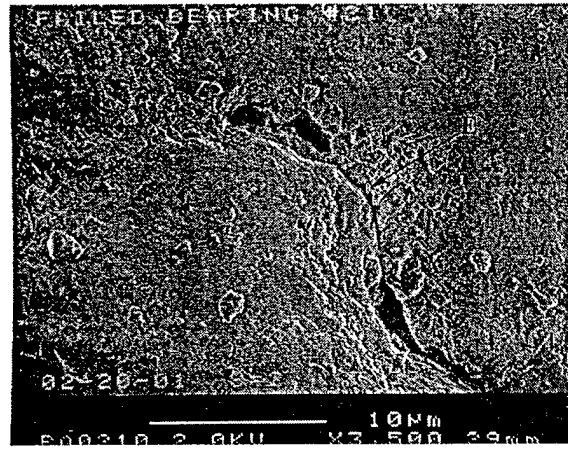
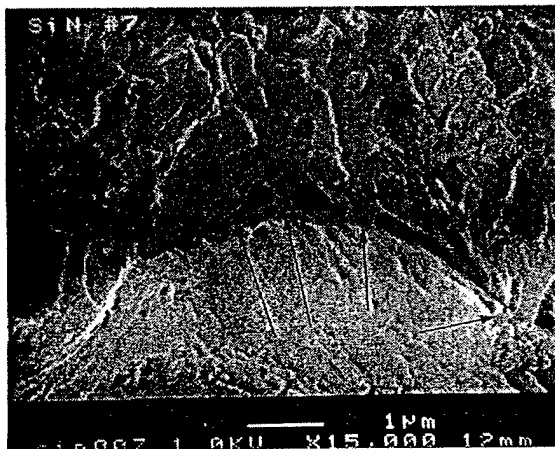
Figures 36, 37, 38, 39, and 40 are progressively higher magnification views (at 95x, 300x, 1500x, 3500x and 15,000x, respectively) of a separate crack-like feature, labeled "E," from an orthogonal perspective. Feature "E" is at the base of feature "A" near feature "D." Feature "A" is labeled in Figures 36, 37, and 38 for orientation. The feature "E" is just inboard of the tightly spaced Wallner lines in the upper right hand corner of Figure 37, which reinforces the notion that feature "E" is in the right location to be the site for fracture initiation.

Figures 39 and 40 show an interesting feature in the crack-like feature "E." Ligaments span the crack-like feature. The ligaments have a distinctive elliptical shape that might be characteristic of the neck that forms during sintering and pore consolidation. The neck's elliptical shape might be interpreted as the negative radius of curvature that forms at the junction between two sintered particles. That is, the ligaments may be the remnants of a string of small sintering voids that did not fully densify. If so, then the ligaments might be expected to be glassy pockets rich in the liquid-phase sintering aids used in this ceramic. It is uncertain, however, whether the ligaments represented the initiation site for the fracture, whether the ligaments developed as damage late in the fracture, or whether the ligaments were unrelated to the fracture.

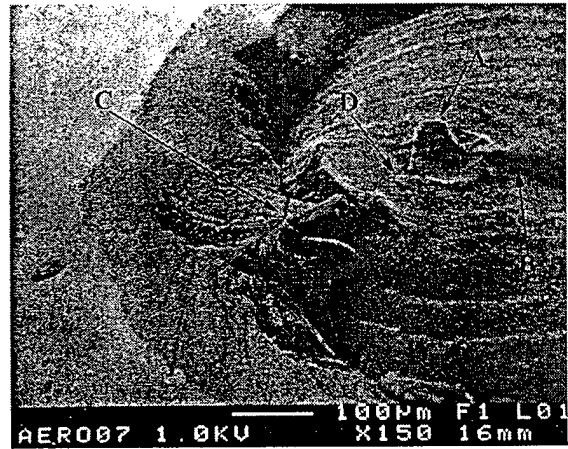
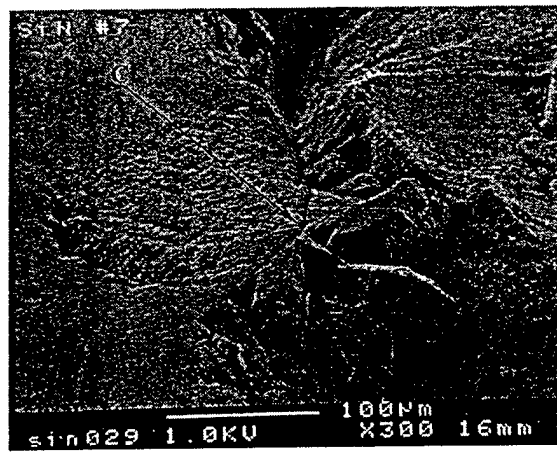
Fig 41

An interesting "star burst" pattern, labeled "C," is visible in Figures 32, 36, 41, and 42. The high-magnification view in Figure 42 shows several cracks radiating from a central "pit." It is uncertain whether the star burst represents the fracture initiation or whether it occurred early or late in the fracture.
